Old West End Roof Survey

Prepared for:
City of Danville
Community Development

Prepared by:
Friends of the Old West End
with the knowledge and expertise of
Outdoor Designs, Inc.

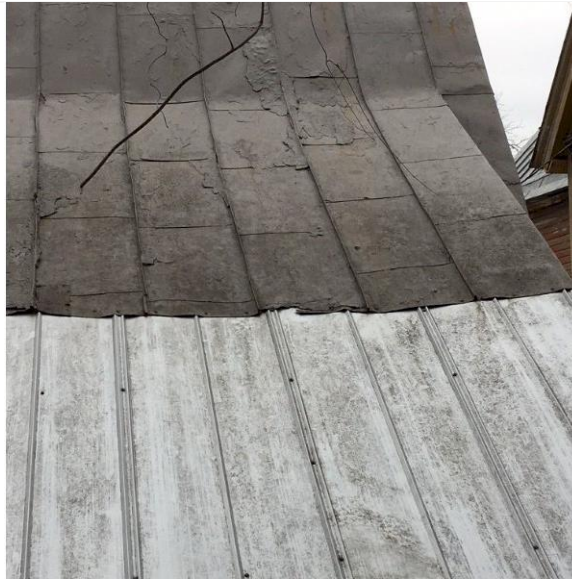
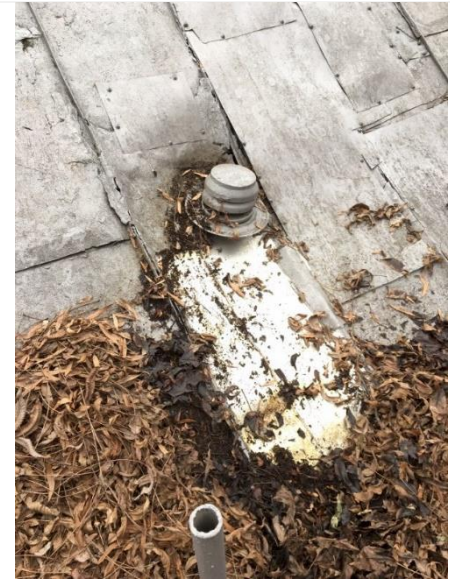
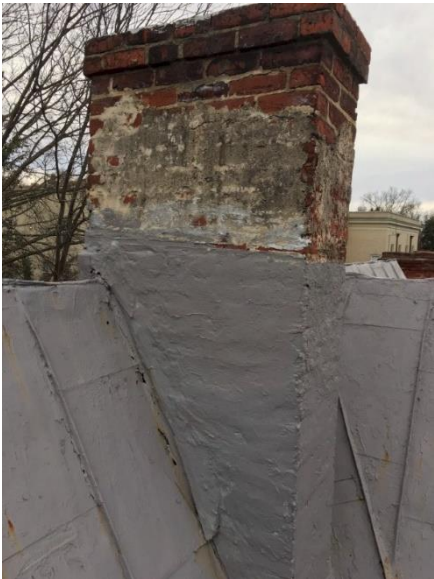
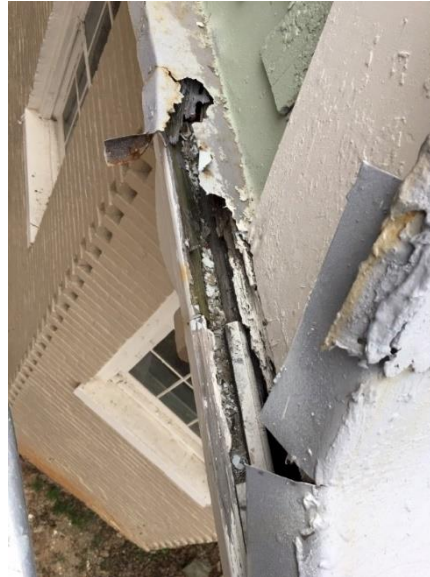
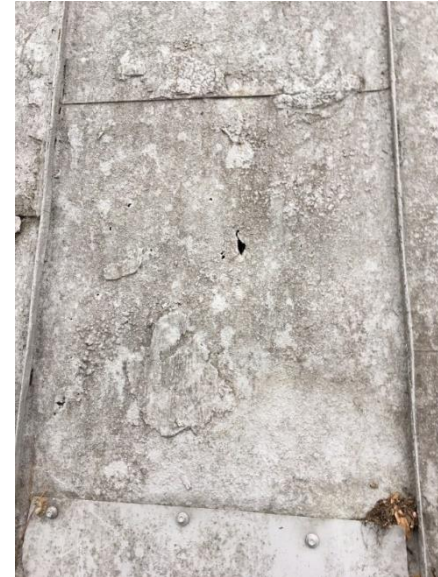
124 Chestnut – Top Roof

Very steep – 16 over 12
Numerous trees in rear
Riddled with holes and patches
Significant metal replacement

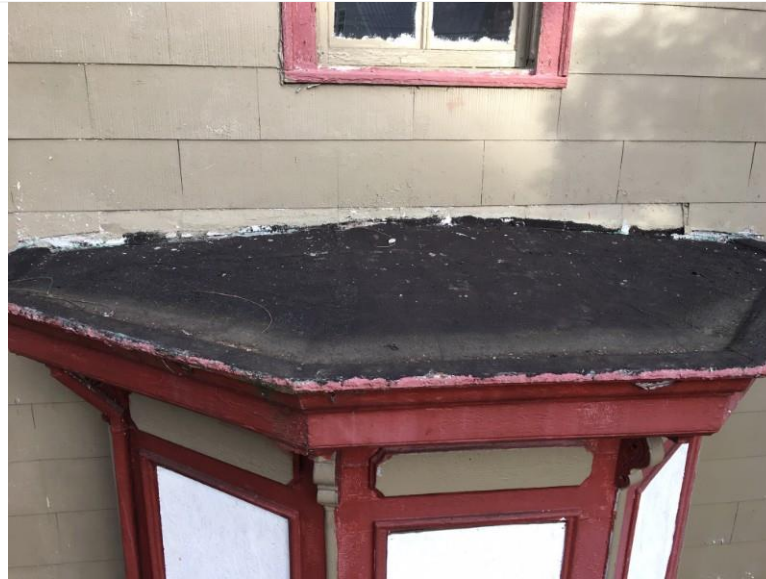
125 Chestnut – Porch and Bay Window

Torch down on Chestnut Street porch
Tar on bay window
Replace both with new standing seam metal

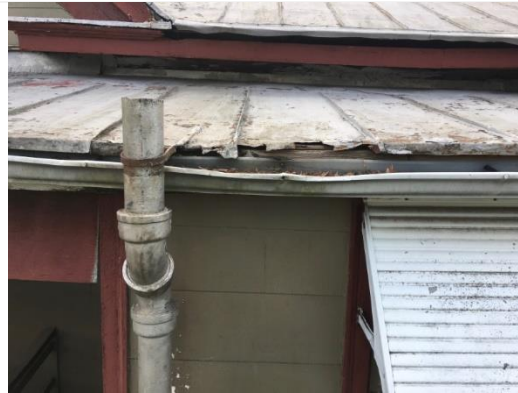
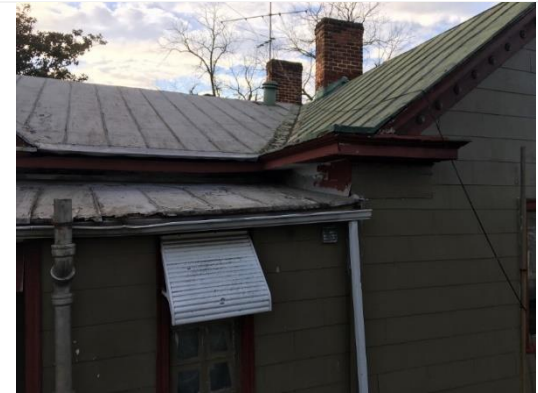
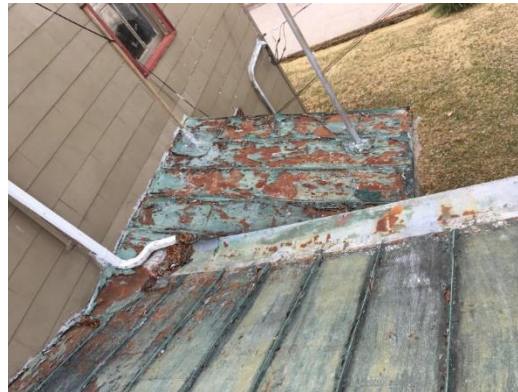
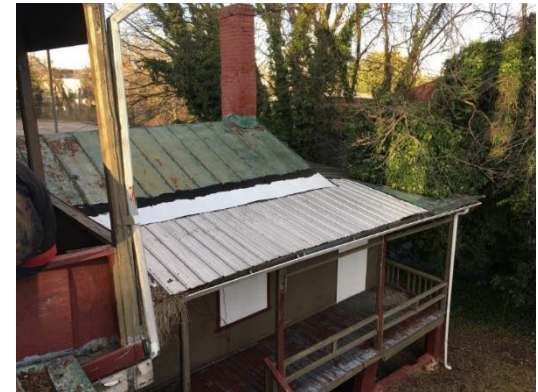
125 Chestnut – Kitchen Section

Some metal replacement
Three kinds of roofing
Significant patches of tar
Need new boots
Needs gutters

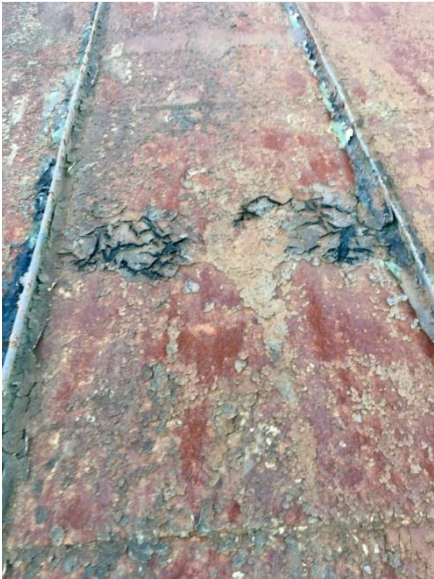
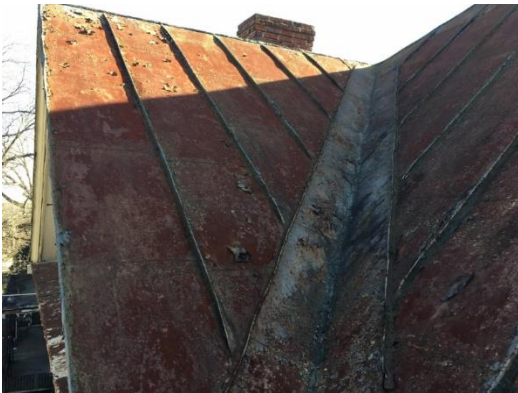
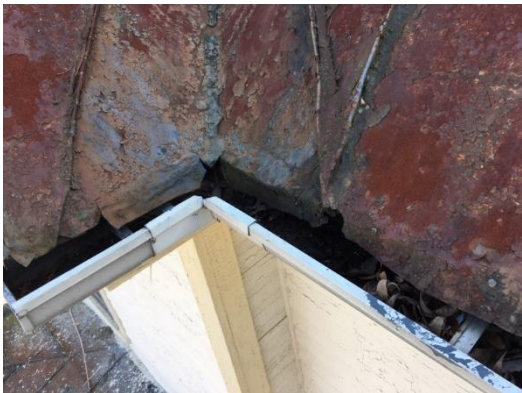
614 Holbrook – Top Roof

Significant rust and tar
Nail pops

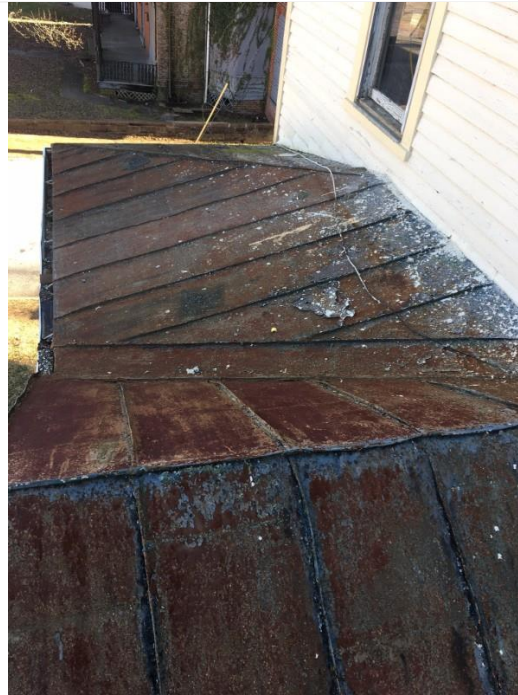
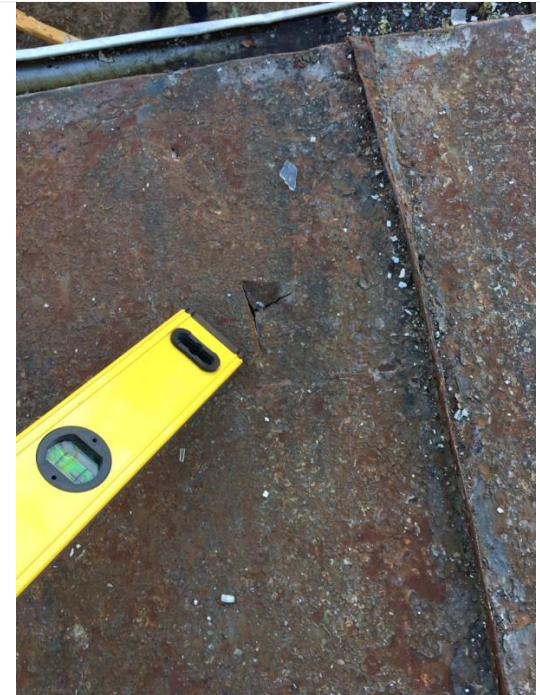
614 Holbrook – Porch

Significant rust
Large hole needs immediate attention

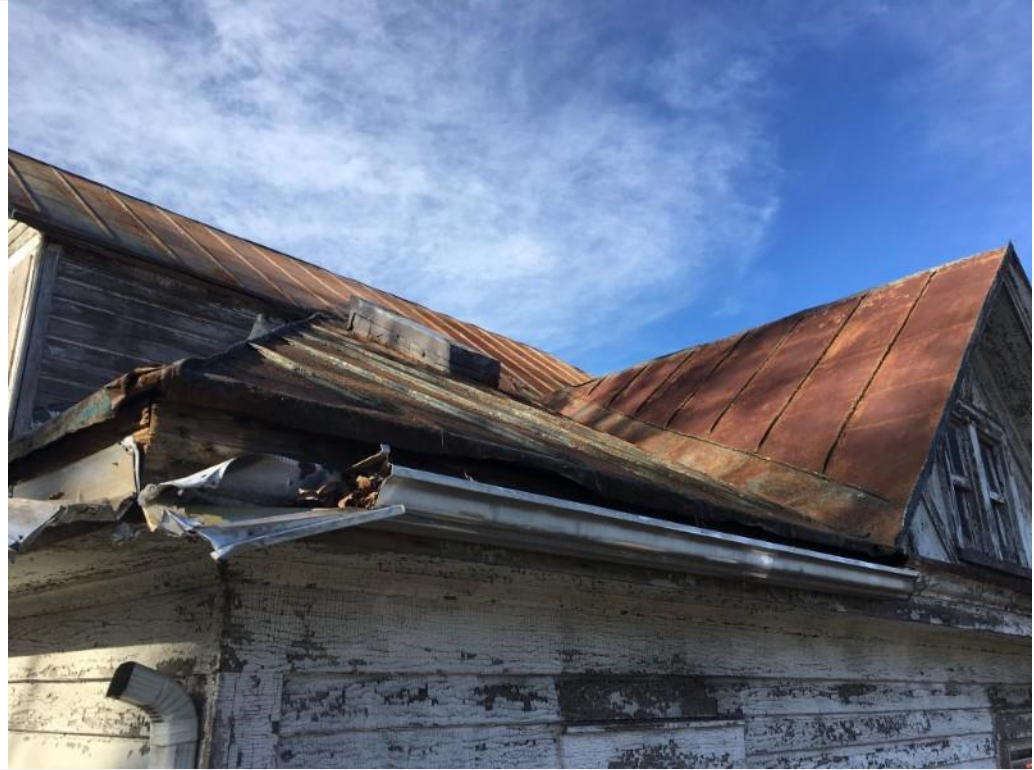
614 Holbrook – Gray Street Addition

Significant rust

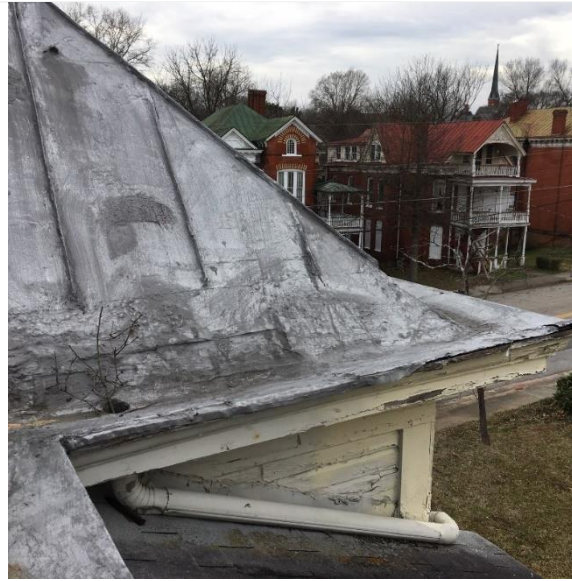
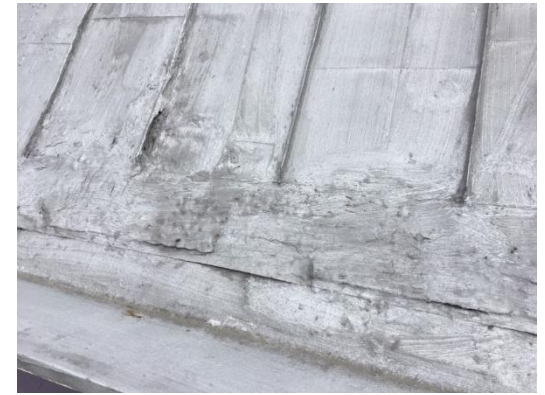
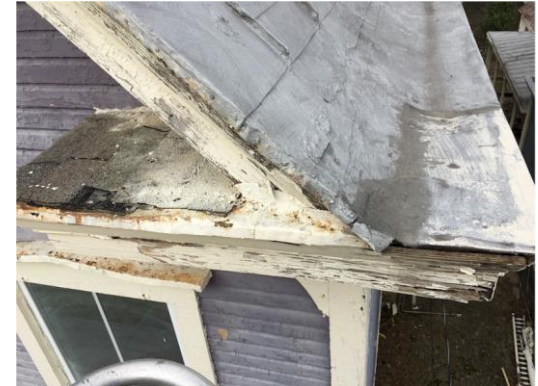
241 Jefferson – Top Roof

Eaves need immediate wood and metal replacement

Otherwise suggest initial patch only to allow present coating to age – will peel off in a few years

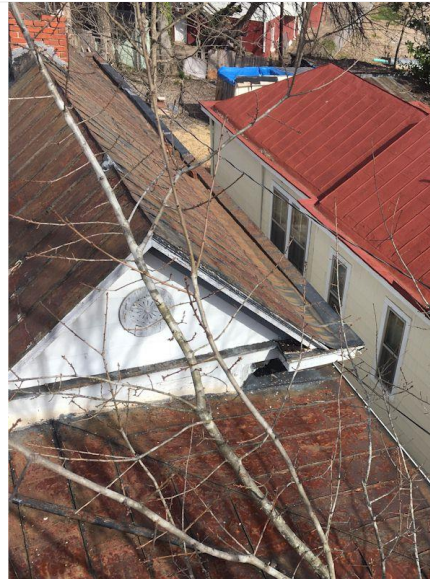
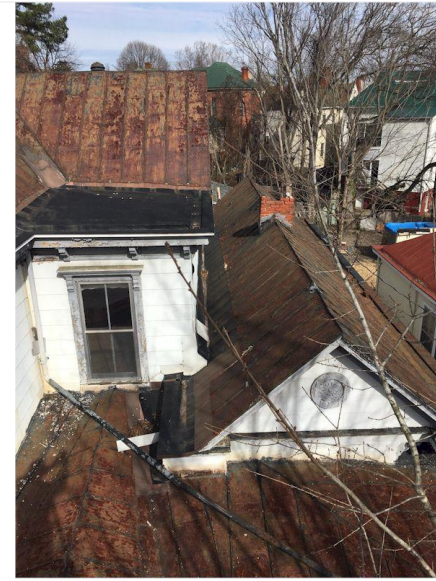
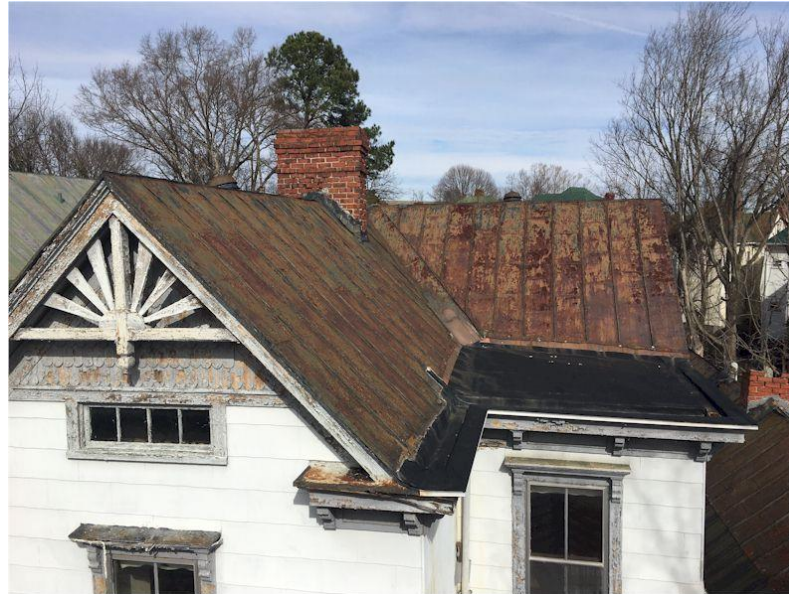
820 Pine – Top Roof

Full replacement recommended. The original terne roof on the front of the house is severely rusted and has been frequently patched in the past. It is unlikely that this roof section could withstand the scraping and sanding required for a new coating.

There are many locations where the terne appears to have been replaced with other metals resulting in galvanic action. This has further weakened the original material.

Replace with new standing seam metal

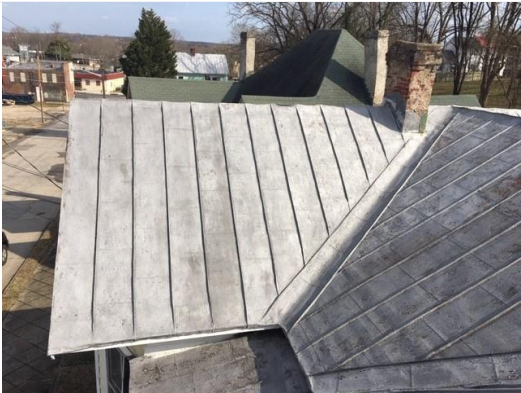
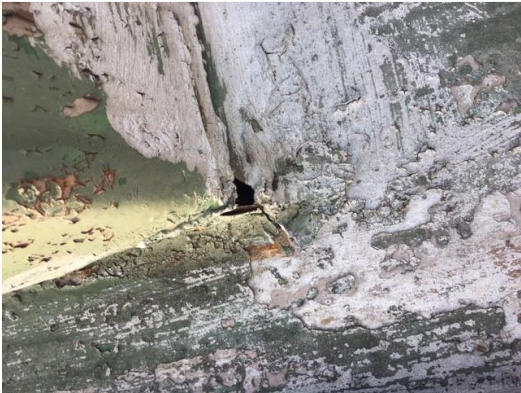
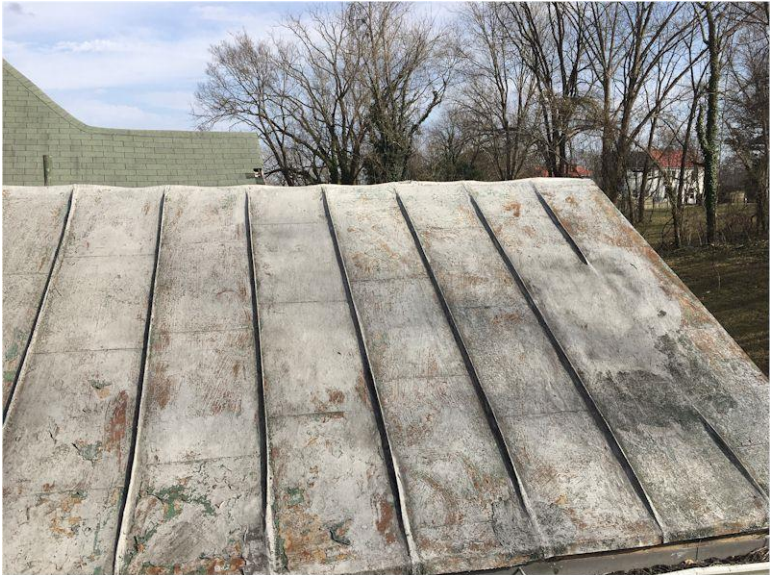
841 Pine – Top Roof

Significant tar

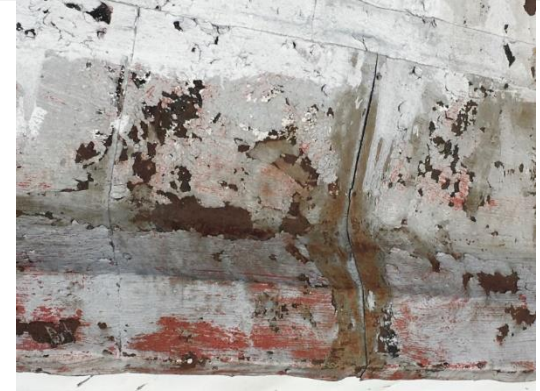
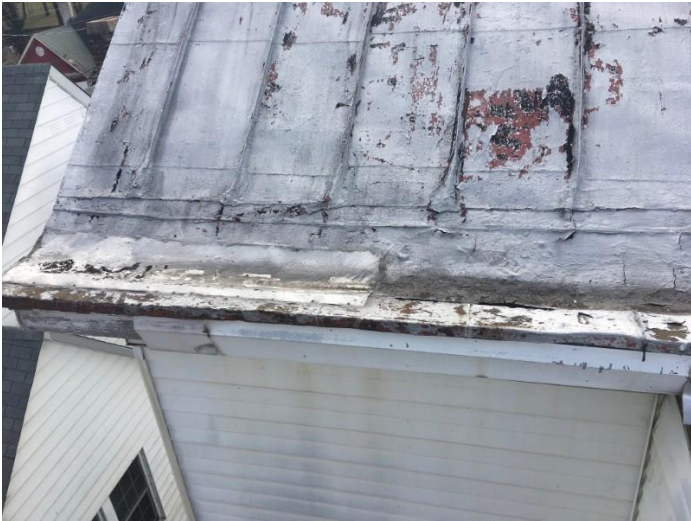
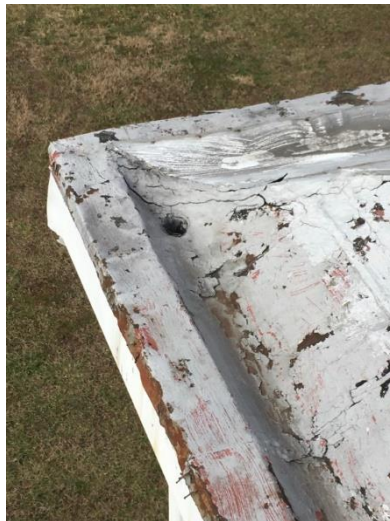
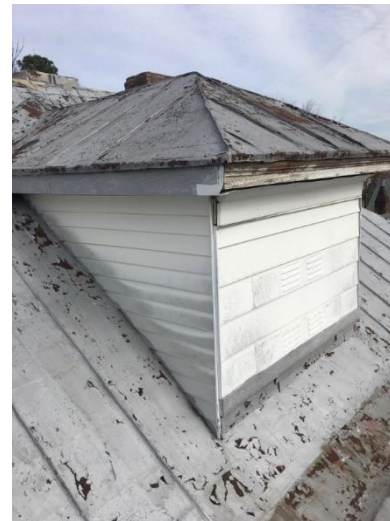
844 Pine – Top Roof

Split seams
Considerable tar
Suggest letting the silver paint weather another year or two

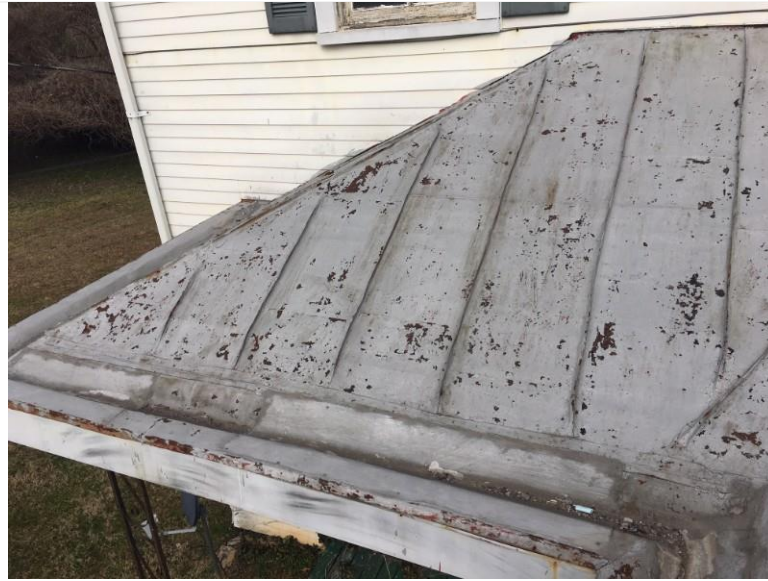
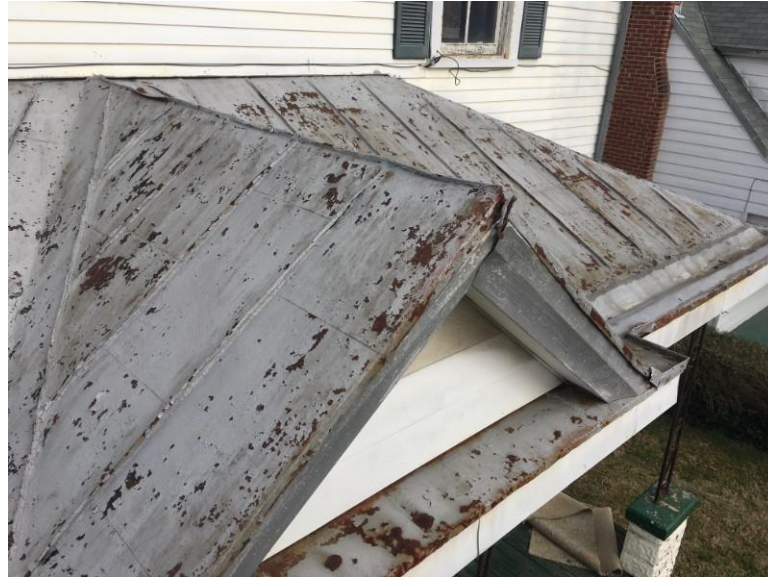
844 Pine – Porch Roof

Some replacement areas
Considerable tar

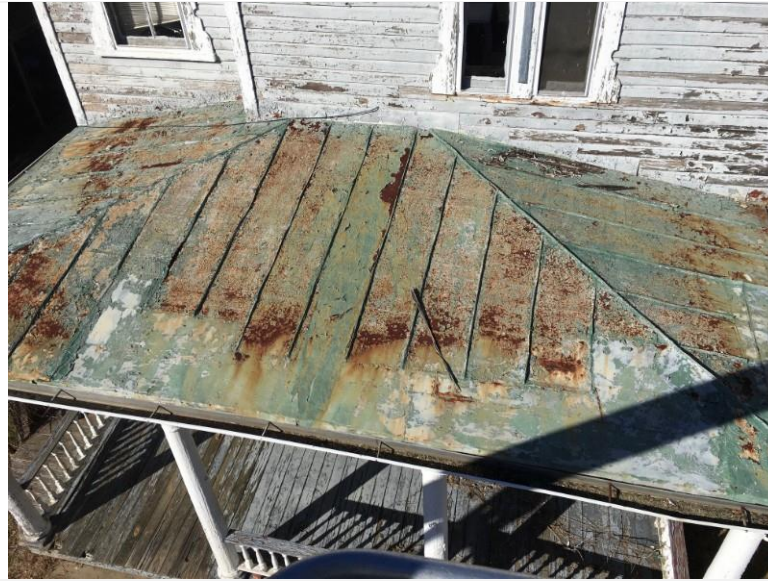
870 Pine – Porch Roof

The porch roof is in poor condition and needs full replacement.

Replace with new standing seam metal

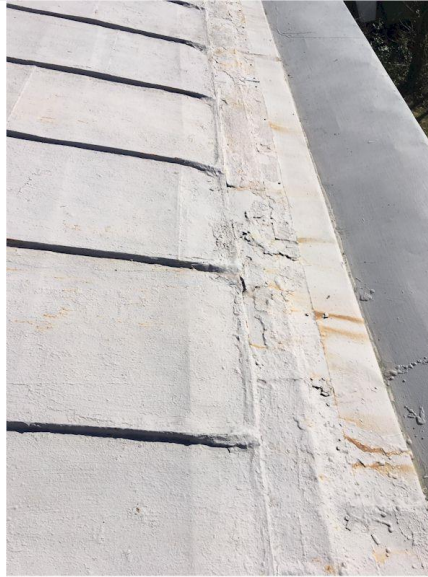
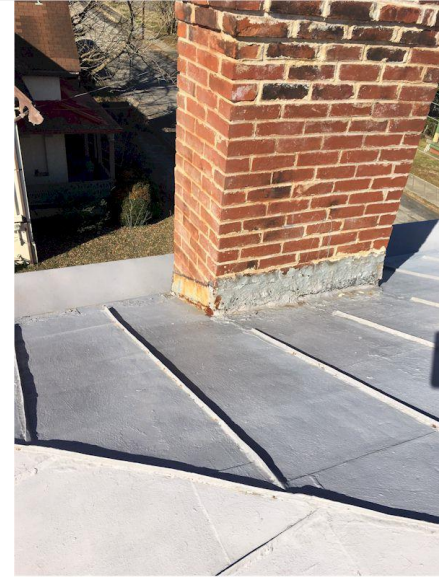
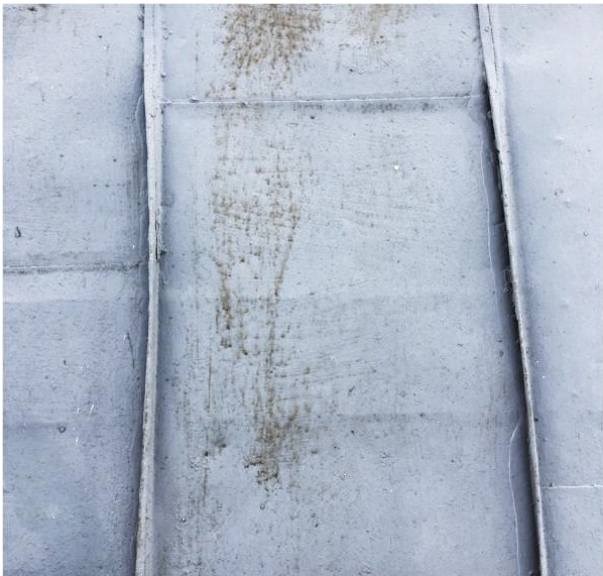
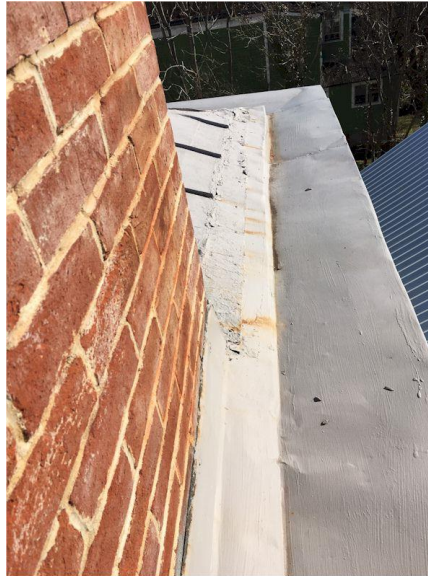
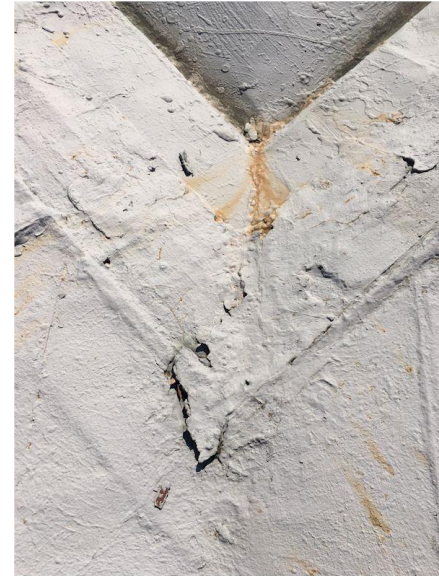
871 Pine – Main building top roof

Paint rusting through
Remove tar under peeling paint
Unpainted areas
Repair chimney flashing
Repair open seams
Repair nail pops

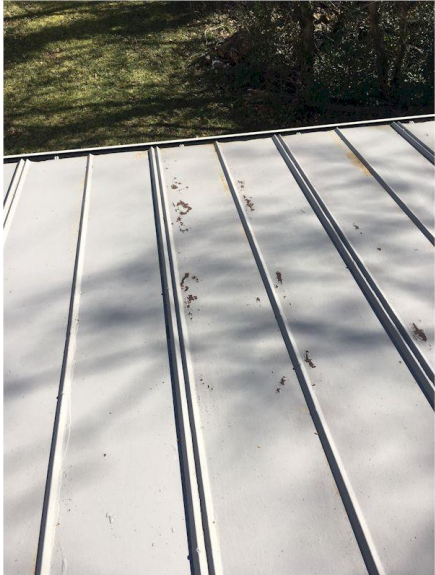
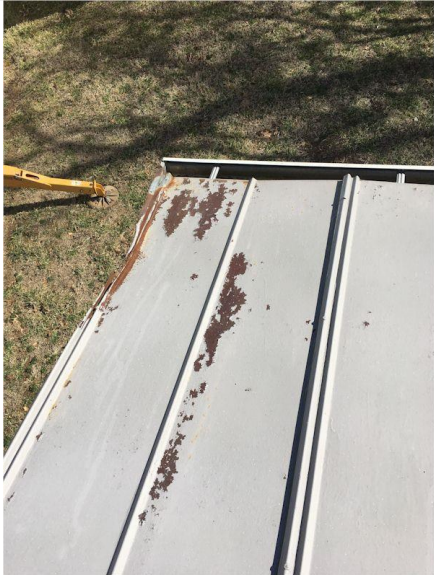
871 Pine – Garage roof

Repair damaged corner section
