Old West End Roof Survey

Prepared for:
City of Danville
Community Development

Prepared by:
Friends of the Old West End
with the knowledge and expertise of
Outdoor Designs, Inc.

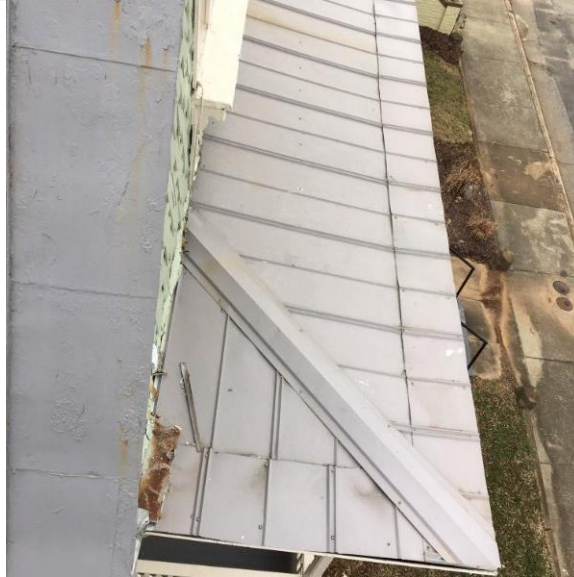
Nearly new condition
Has leaf guards

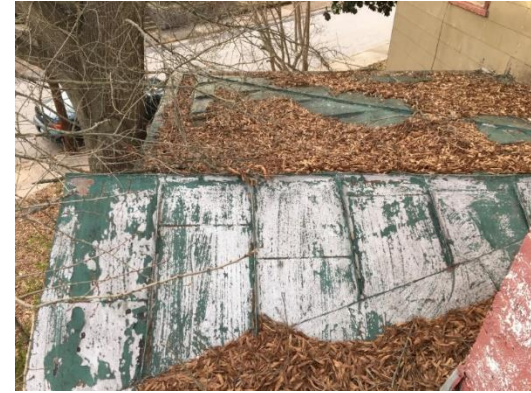
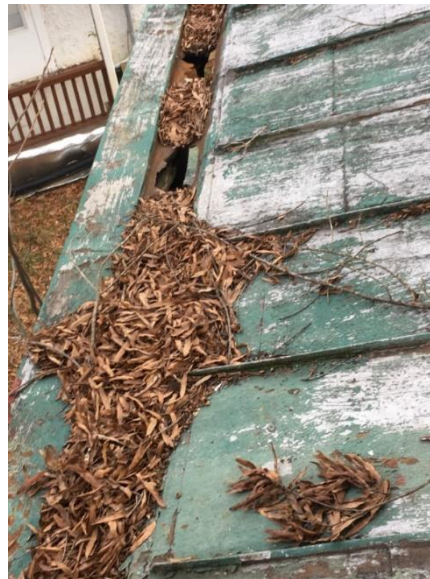
Some metal replacement (hidden gutter)
Little paint remains

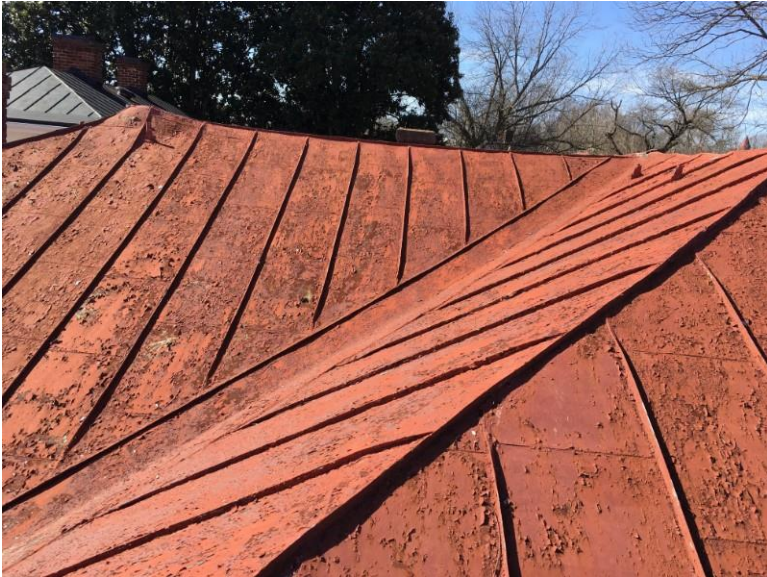
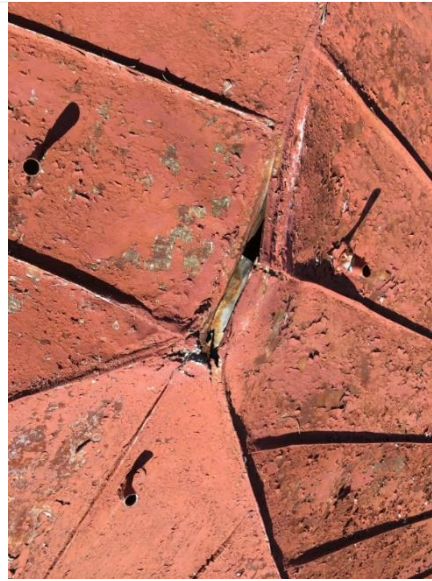
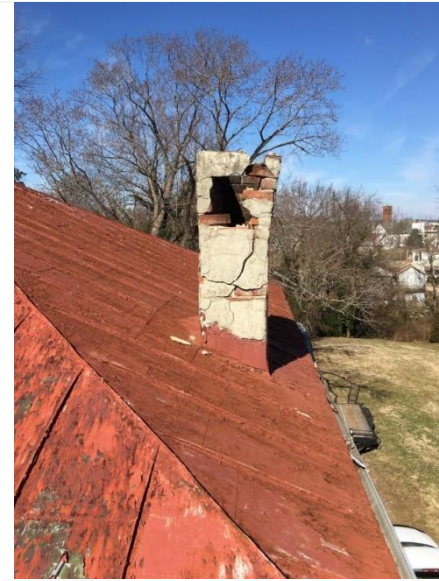
862-866 Green – Top Roof

Grind antenna attachments
Repair three humps at ridge

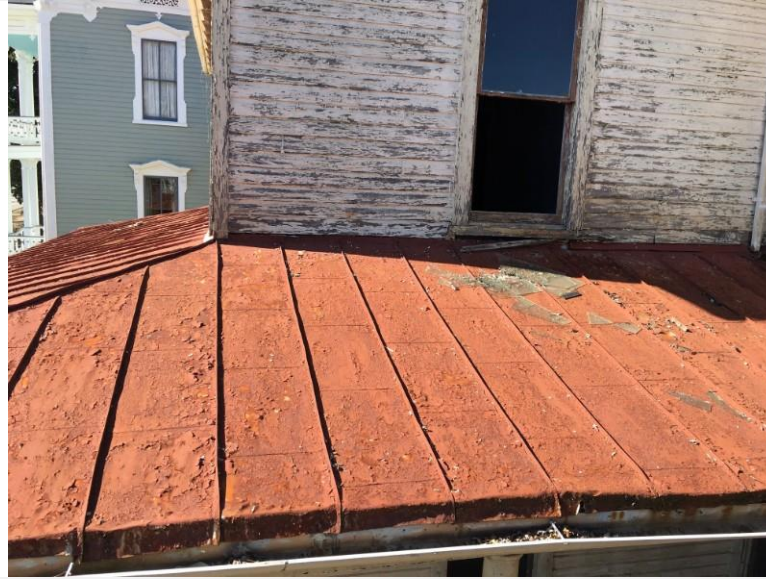
Facia board and round gutters need repair
Scrape, sand, patch, and coat

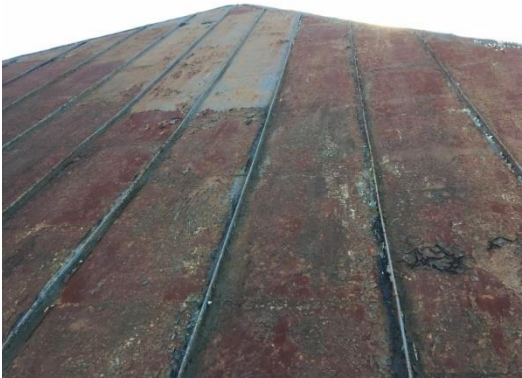
614 Holbrook – Top Roof

Significant rust and tar
Nail pops

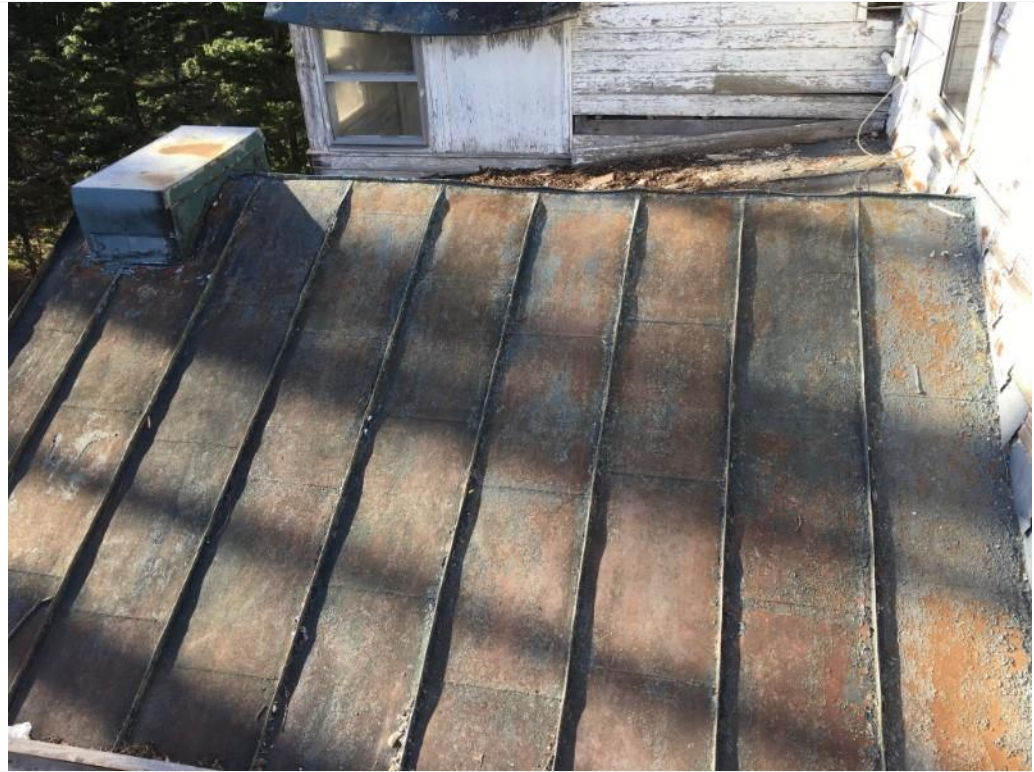
Significant rust

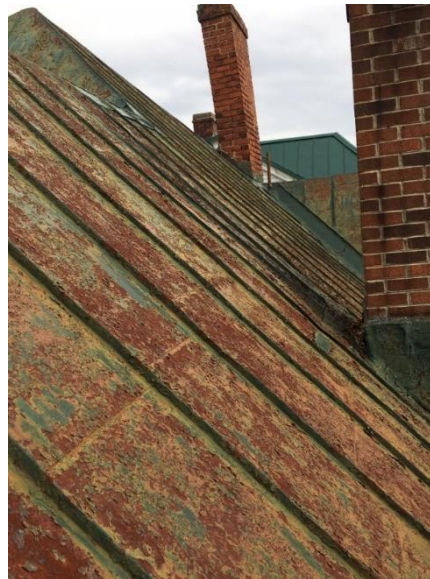
238 Jefferson – Top Roof

Significant rust
Could not see left (southeast) side
Steep

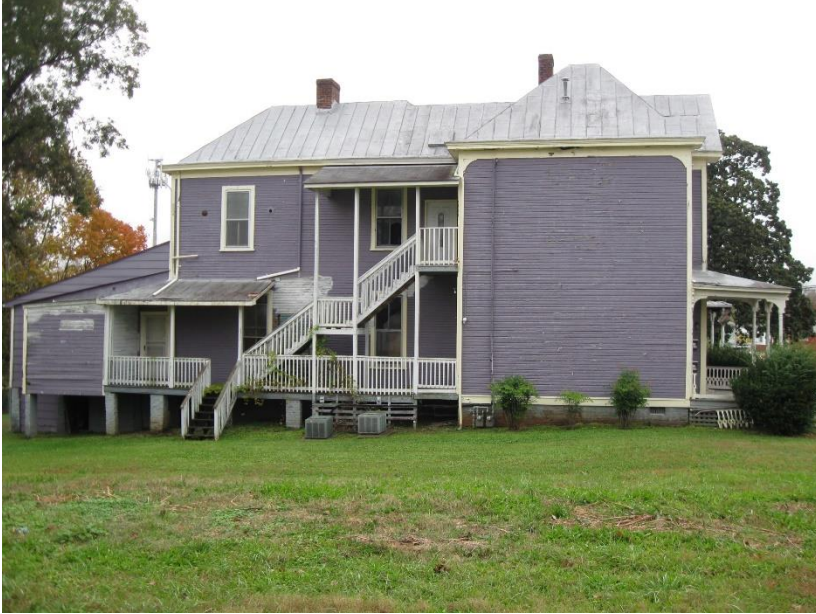
241 Jefferson Avenue – Side (northwest)

Eaves need immediate wood and metal replacement

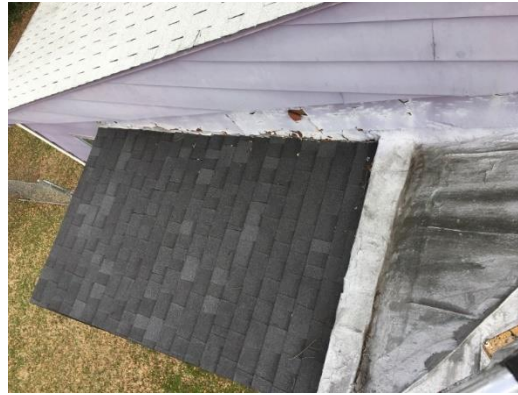
Lower Rear

Upper shingle roof – no work required
Lower – combine and replace all with new metal

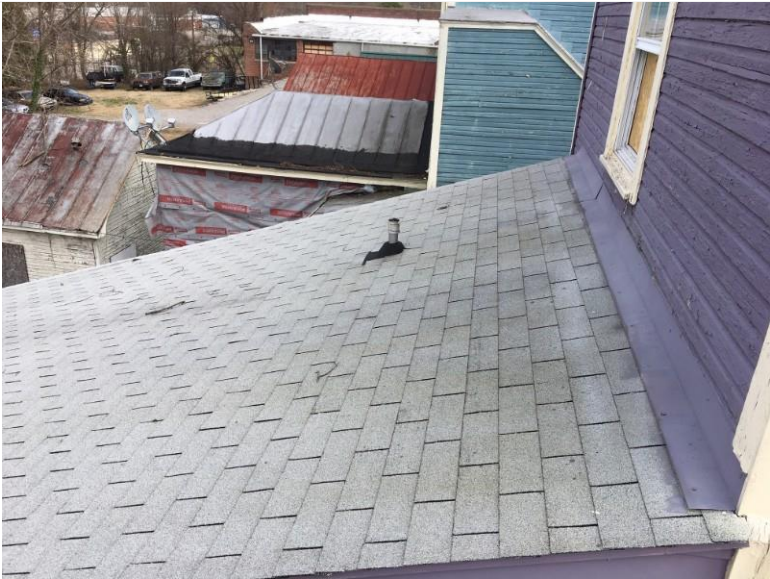
241 Jefferson – Rear Shed Roof

No work required

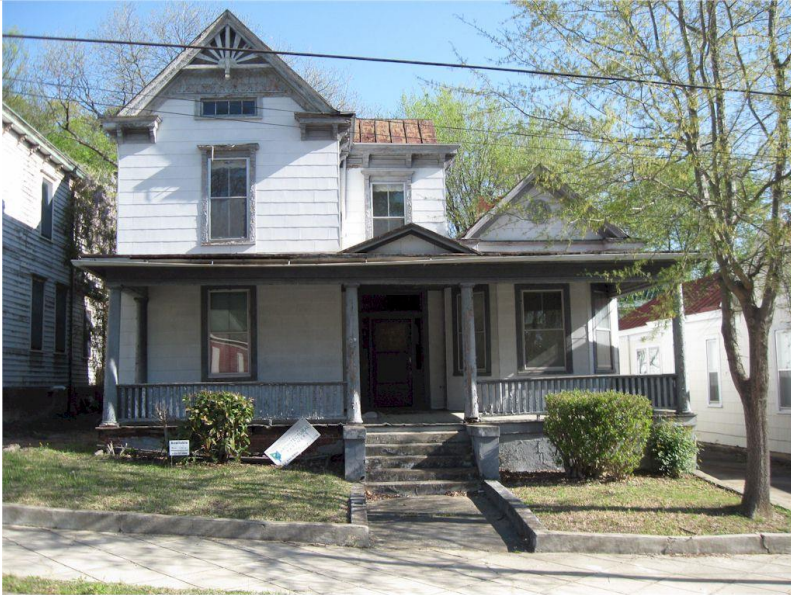
820 Pine Street – Façade (south)

Full replacement recommended. The original terne roof on the front of the house is severely rusted and has been frequently patched in the past. It is unlikely that this roof section could withstand the scraping and sanding required for a new coating.

There are many locations where the terne appears to have been replaced with other metals resulting in galvanic action. This has further weakened the original material.

For this house to remain viable, near-total roof replacement is required. An overall architectural review is likely needed.

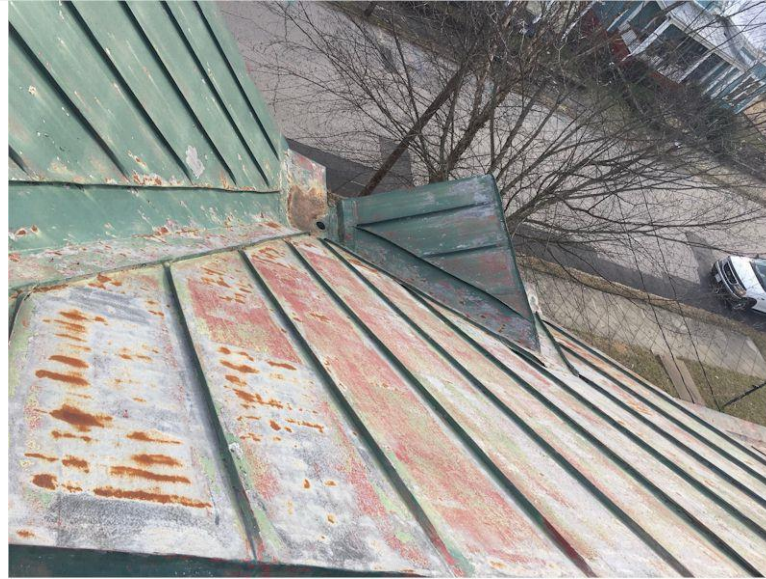
830 Pine – Top Roof

Only one hole observed
Standing water needs filler
Scrape, sand, patch, and coat

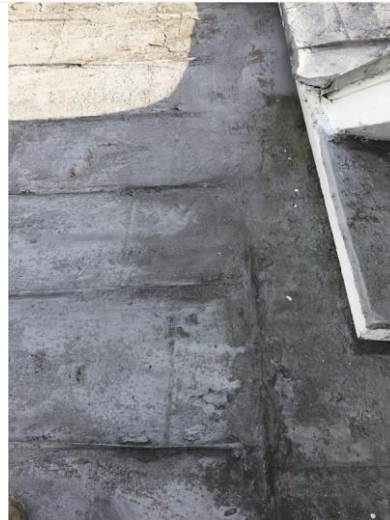
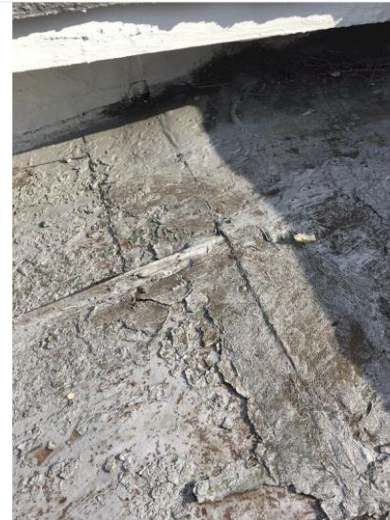
Significant tar
May need replacement at double the cost

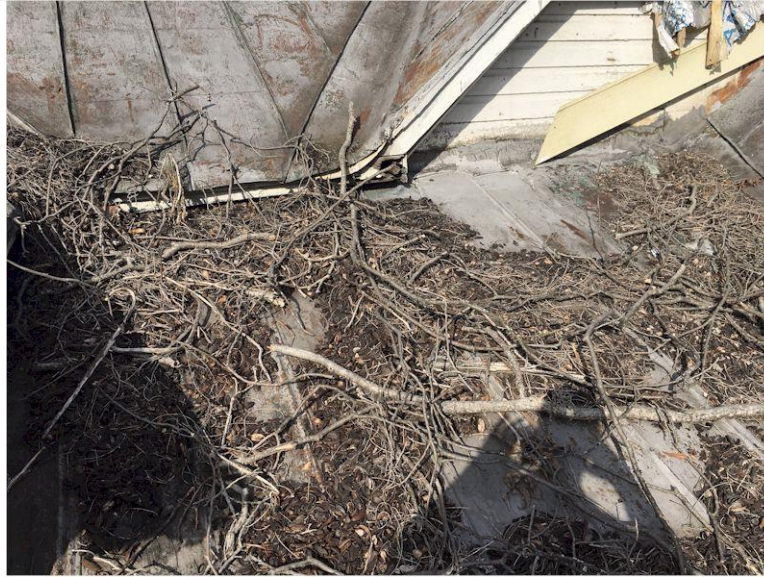
841 Pine – Rear Shed Roof

Significant debris
Difficult to evaluate

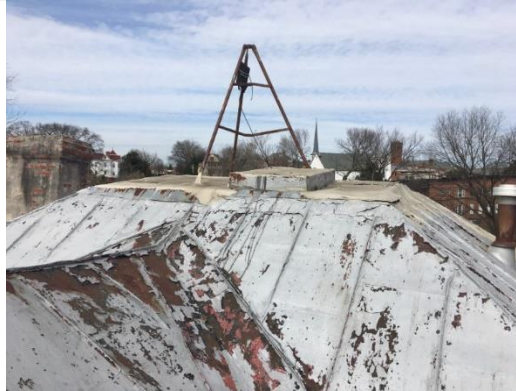
844 Pine – Top Roof

Split seams
Considerable tar
Suggest letting the silver paint weather another year or two

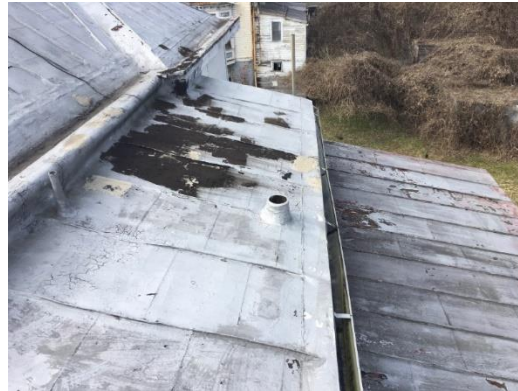
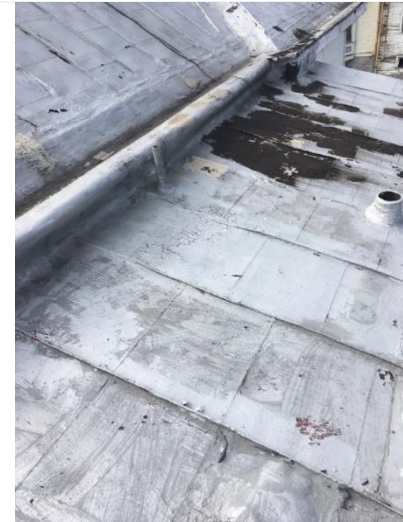
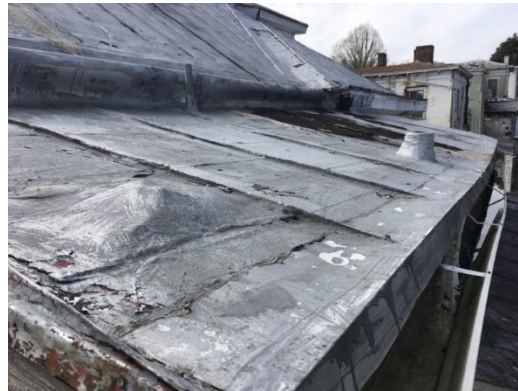
Roof repairable but structure unsound
Considerable tar
Some replacement metal required

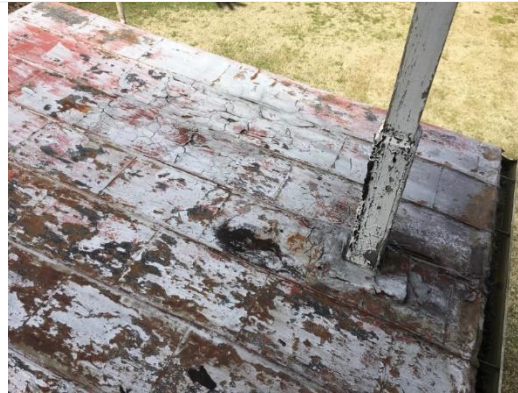
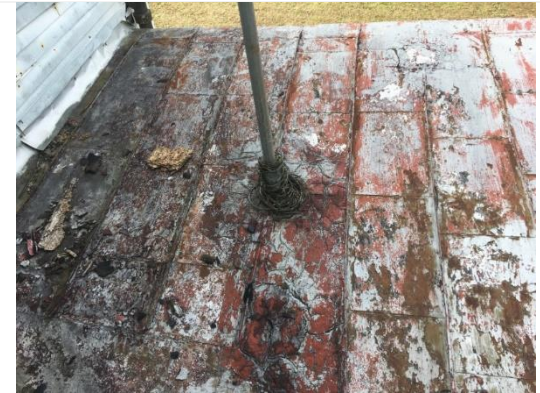
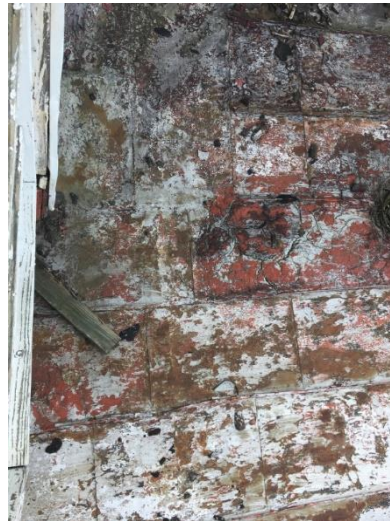
844 Pine – Left Rear Shed Roof

There is a large hump which may be a closed-up vent or a structural problem

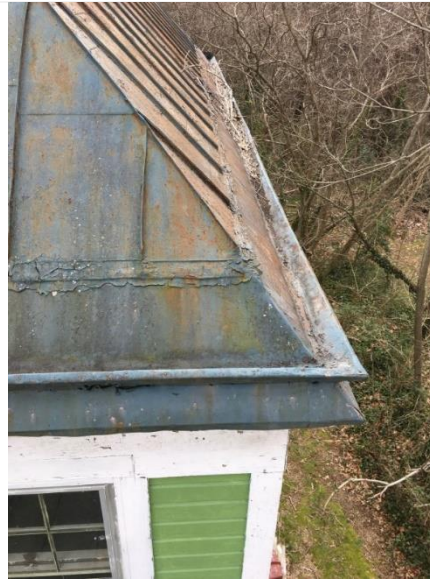
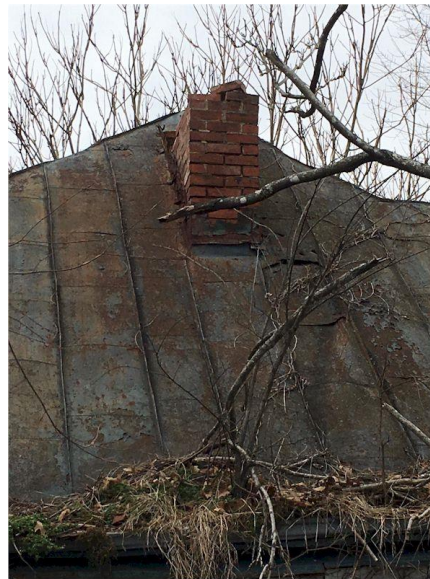
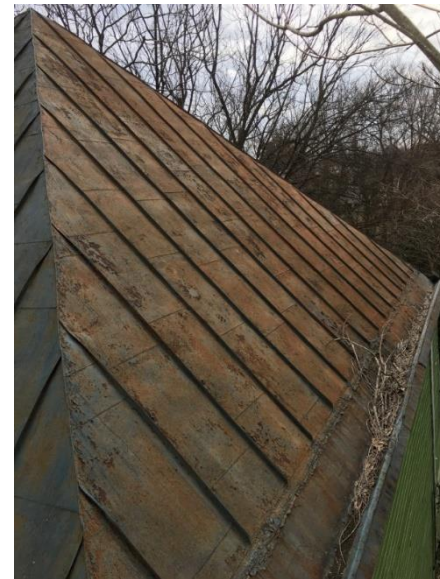
861 Pine – Top Roof

Chisel tar from splices and seams
Wood replacement on front gable
Unique hidden gutter
Several large holes need immediate attention

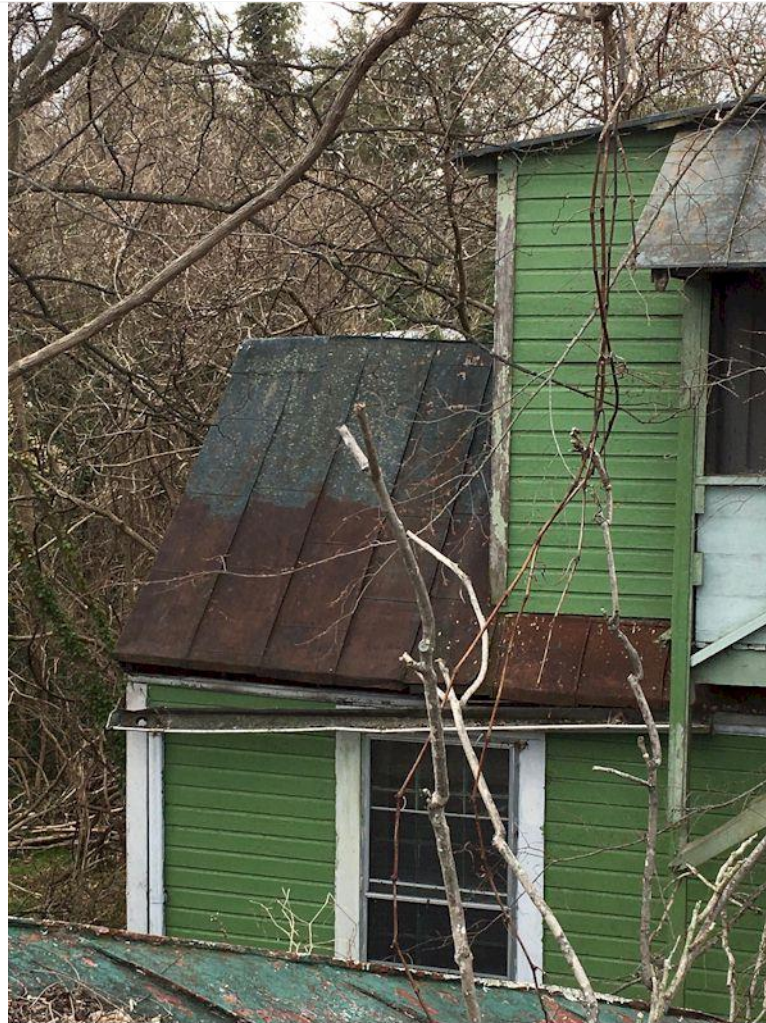
861 Pine – Rear Addition

No access – difficult to assess

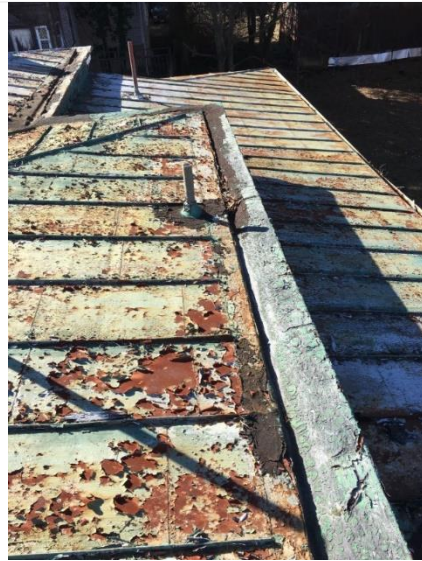
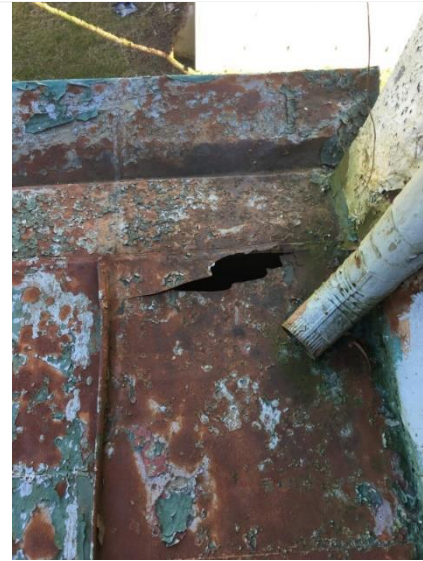
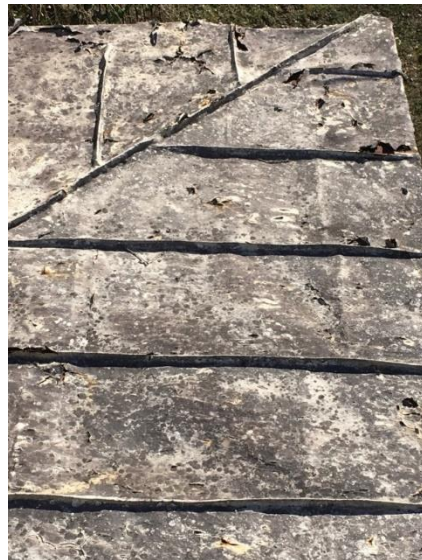
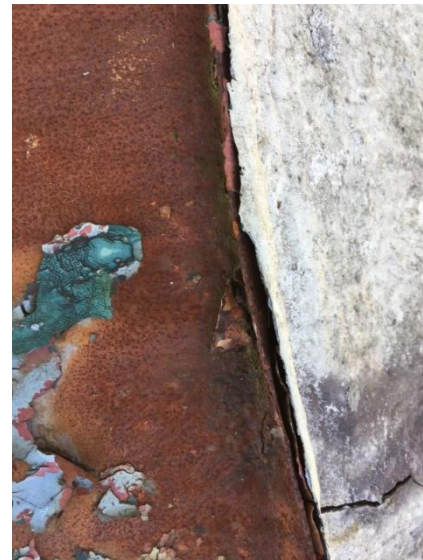
The rear section is in poor condition and would require a new roof. It may be more economical to replace this entire portion of the home with new construction.

Replace with new standing seam metal

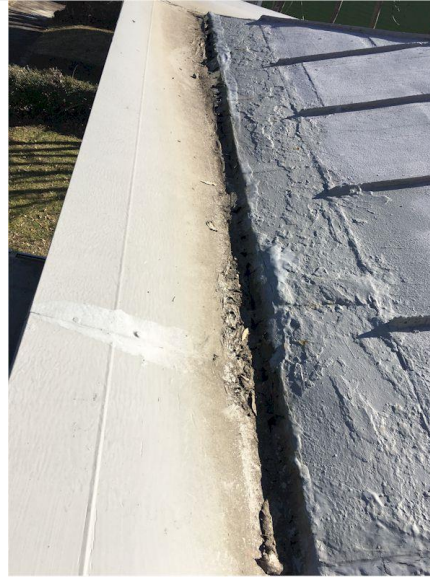
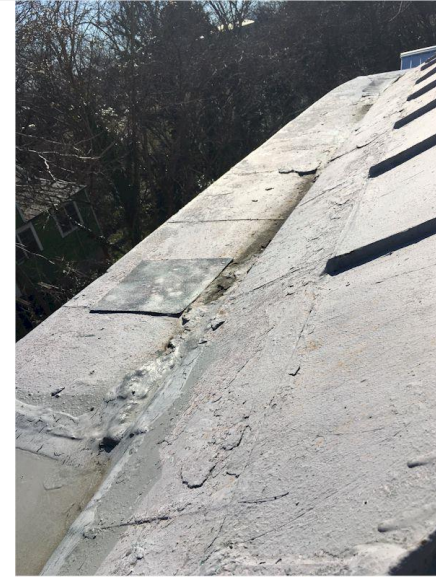
Paint rusting through
Remove tar under peeling paint
Remove shingle patchwork
Repair hidden gutters
Repair open seams

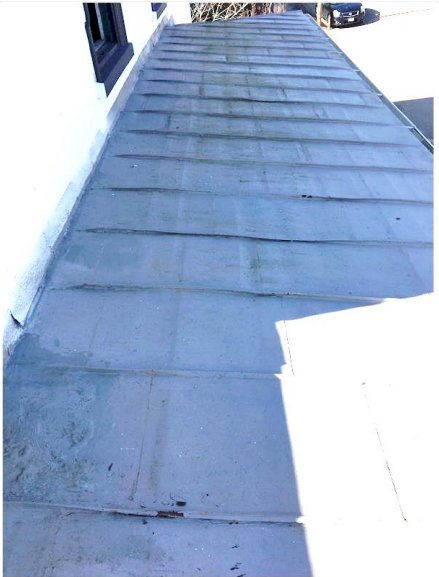
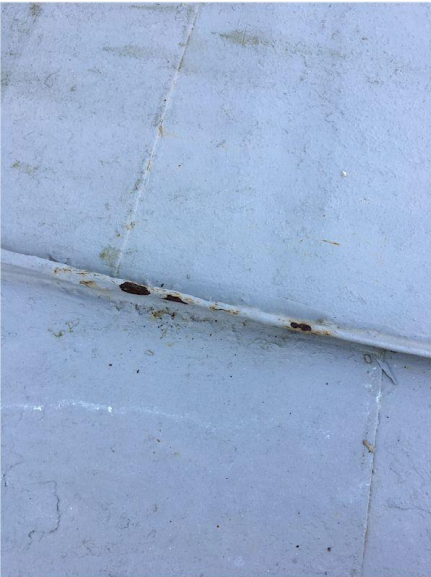
871 Pine – Main building porch roof

Raised flattened seams
Paint peeling from seams

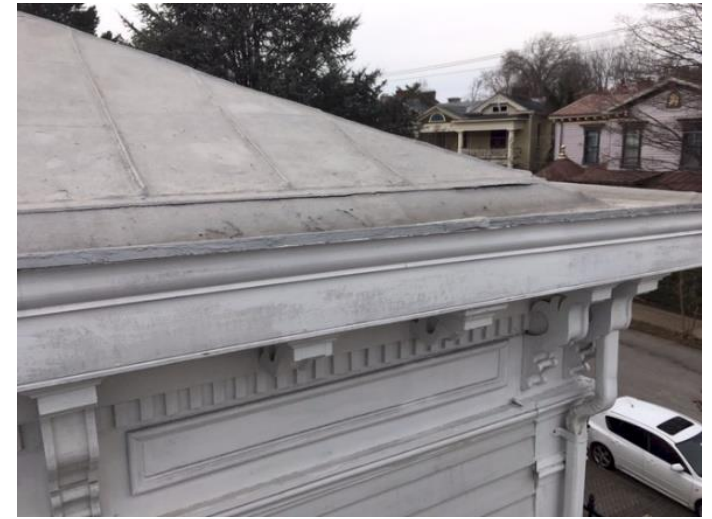
This roof was treated fifteen years ago. Only a single coat of GacoRoof was applied with no special treatment for the hidden gutters. Only recently have leaks developed in the gutters. They will soon be repaired using the manufacturers recommendation of liquid roof tape in the gutters.

Despite the use of half the recommended coating, the main roof (at right) is leak free and still has the same appearance as it did fifteen years ago with no fading or cracking.
